# *Recall Notice*

### **NPK RECALLS HAMMER TOP BRACKETS CONFIGURED FOR S-SERIES QUICK COUPLERS (ALSO RECOGNIZED AS BADGER HAMMER CAPS FOR VOLVO EXCAVATORS)**

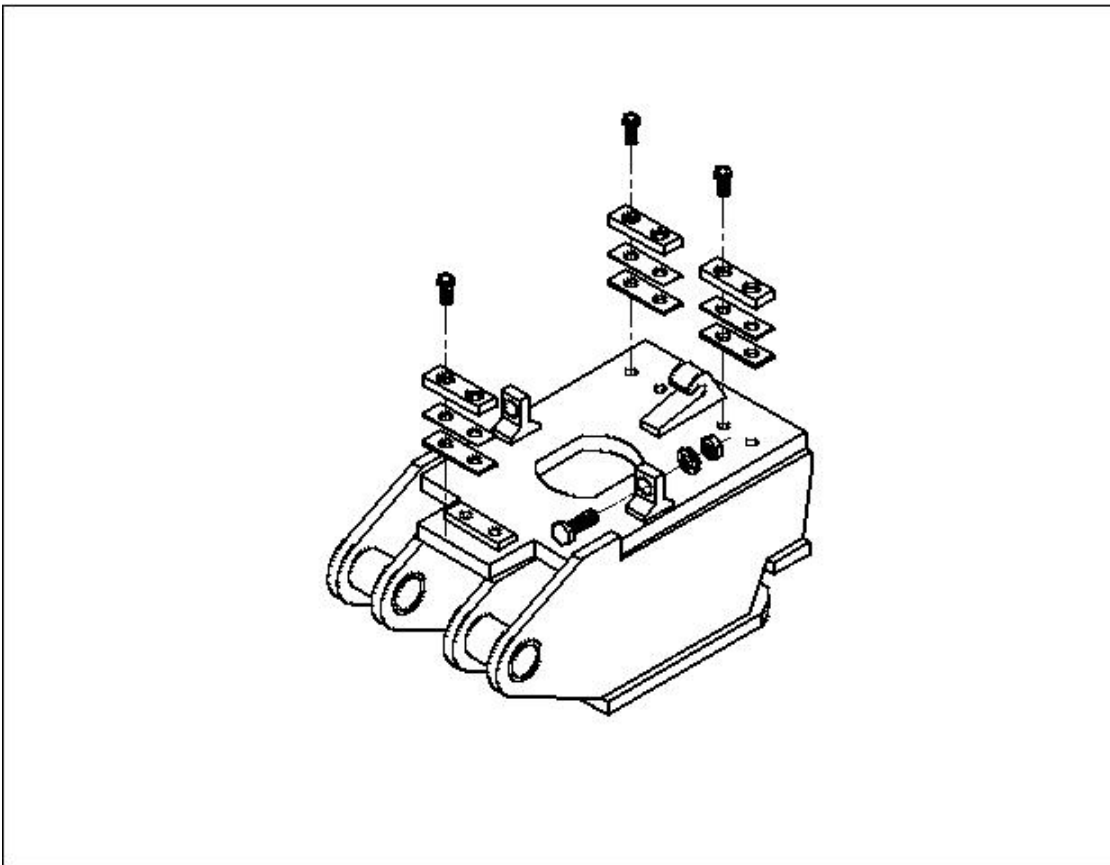
**Description:**

**Hazard:** A few of the S-Series Quick Couplers (Hammer Top Brackets/Caps) have failed during use unexpectedly releasing the hammer. The unexpected release of the hammer, which weighs thousands of pounds, poses a risk of serious injury or death to persons and a risk of significant damage to property.

- S1 Hammer/Crusher Caps
- S2 Hammer/Crusher Caps
- S3 Hammer/Crusher Caps

(Note: S-Style top brackets for compactor applications are not being recalled.)

**Remedy:** Immediately cease all use of the S-Series Quick Couplers (Hammer Top Brackets/Caps; also recognized as Badger Hammer Caps for Volvo Excavators). Please contact the NPK Recall Contact person listed with any questions. **NPK Recall Contact: Mike Rzeszotarski 800-225-4379, [miker@npkce.com](mailto:miker@npkce.com)**
